REPORT NUMBER: FHWA-AZ89-257

SLOPE EROSION CONTROL FOR URBAN FREEWAYS IN ARID CLIMATES

Volume I - Final Report

June 1989

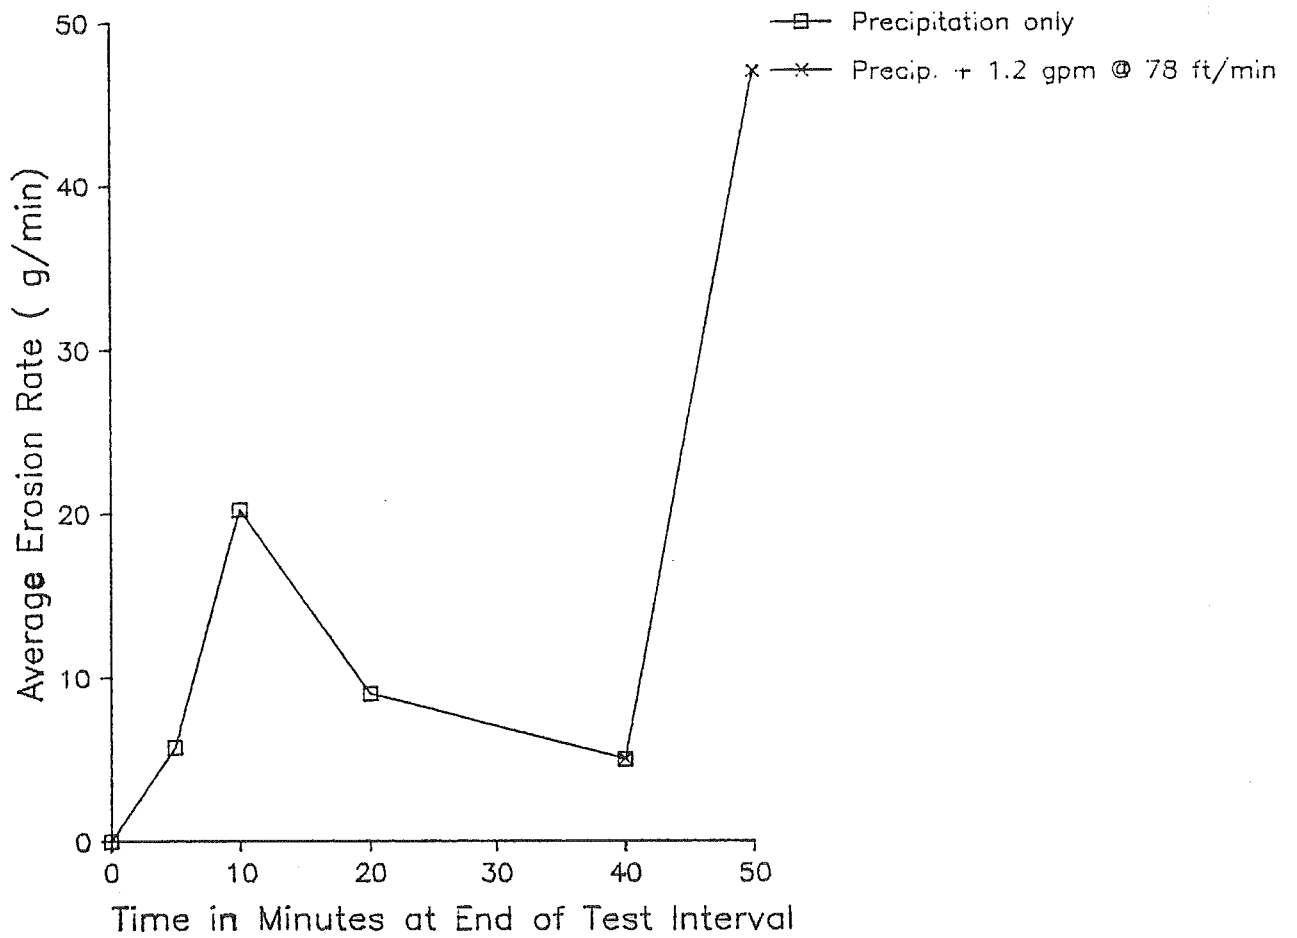
Figure 15. SRG1 Erosion Vs. Time, Combined Flow Conditions, for 2:1 Slope

shown on Figure 15. The precipitation only erosion increased to a maximum value 10 minutes into the test and then continually decreased to a minimum value at 40 minutes.

The reason for the initial increase in the rate of erosion is believed to be caused by surface irregularities left after panel preparation and "poorly" placed coarser particles which are in rather unstable positions at the start of precipitation.

cipitation and overland flow was felt, (Figure 15). Even after 40 minutes of previous testing the erosion rate more than doubled. This increase in erosion occurred as particles which had been stable under the previous flow regime proved unstable under the new one. Figure 15 makes it clear that any erosion prediction must consider the overland contribution if the true material erosion resistance is to be predicted.

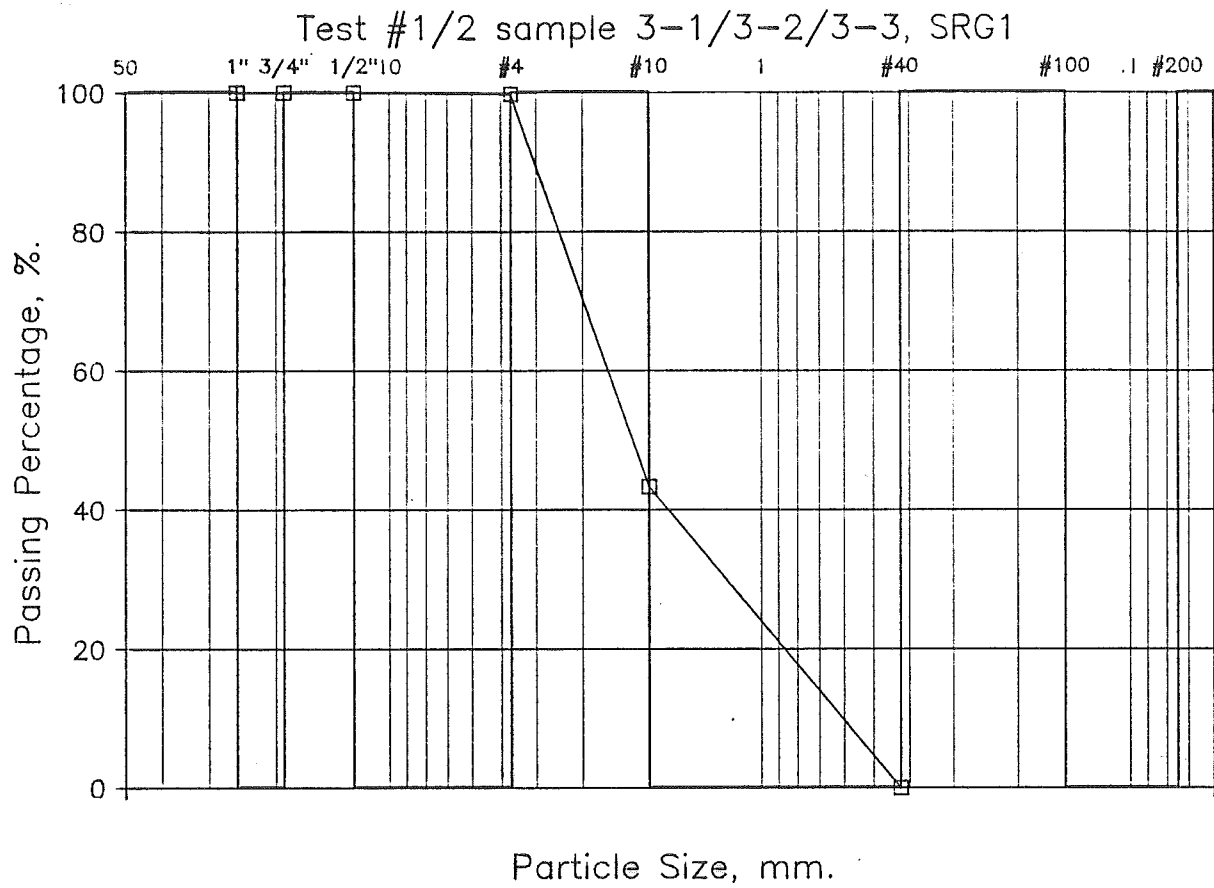
Figure 17. SRG1 Grain Size Analysis after 20 Minutes of Precipitation Induced Erosion

Figures 17 and 18 show similar results. These data show that it is the minus number 4 sieve size particles that are transported by precipitation alone.

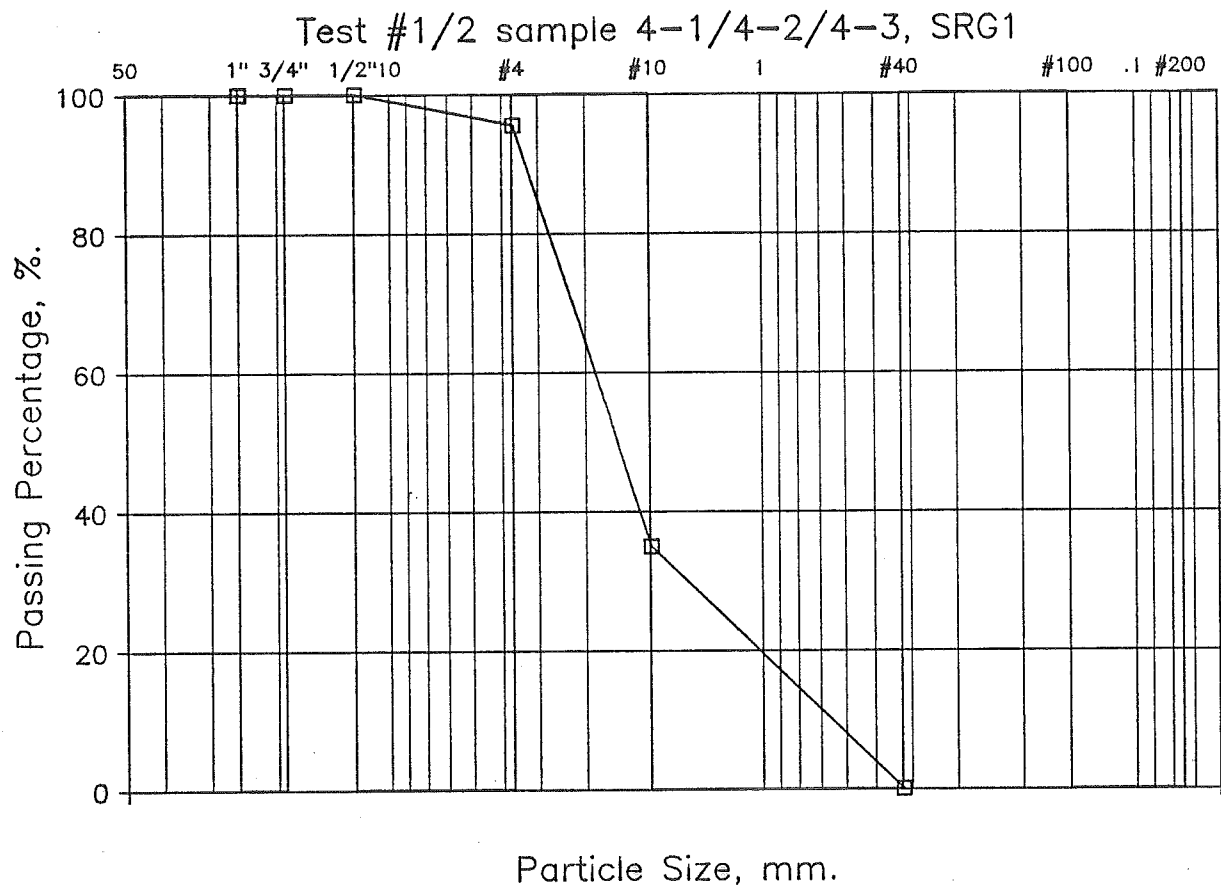
Figure 18. SRG1 Grain Size Analysis after 40 Minutes of Precipitation Induced Erosion

Another interesting observation apparent when Figure 18 is examined concerns the relatively steady state processes at work on the soil face. The percentage of plus number 4 size particles collected increased from 0 at 30 minutes to approximately 5 percent at the end of 40 minutes. While very small, this increase in the plus number 4 size particles is to be expected as the slope continues to be stressed by the precipitation. As long as fines continue to be removed the coarse particles will be shifting into more stable positions. The fact that these coarse particles are in motion provides some particles sufficient movement to be transported from the panel. This soil is so efficient at developing protection by the armoring process plus number 4 size particles involved in large movements are few.

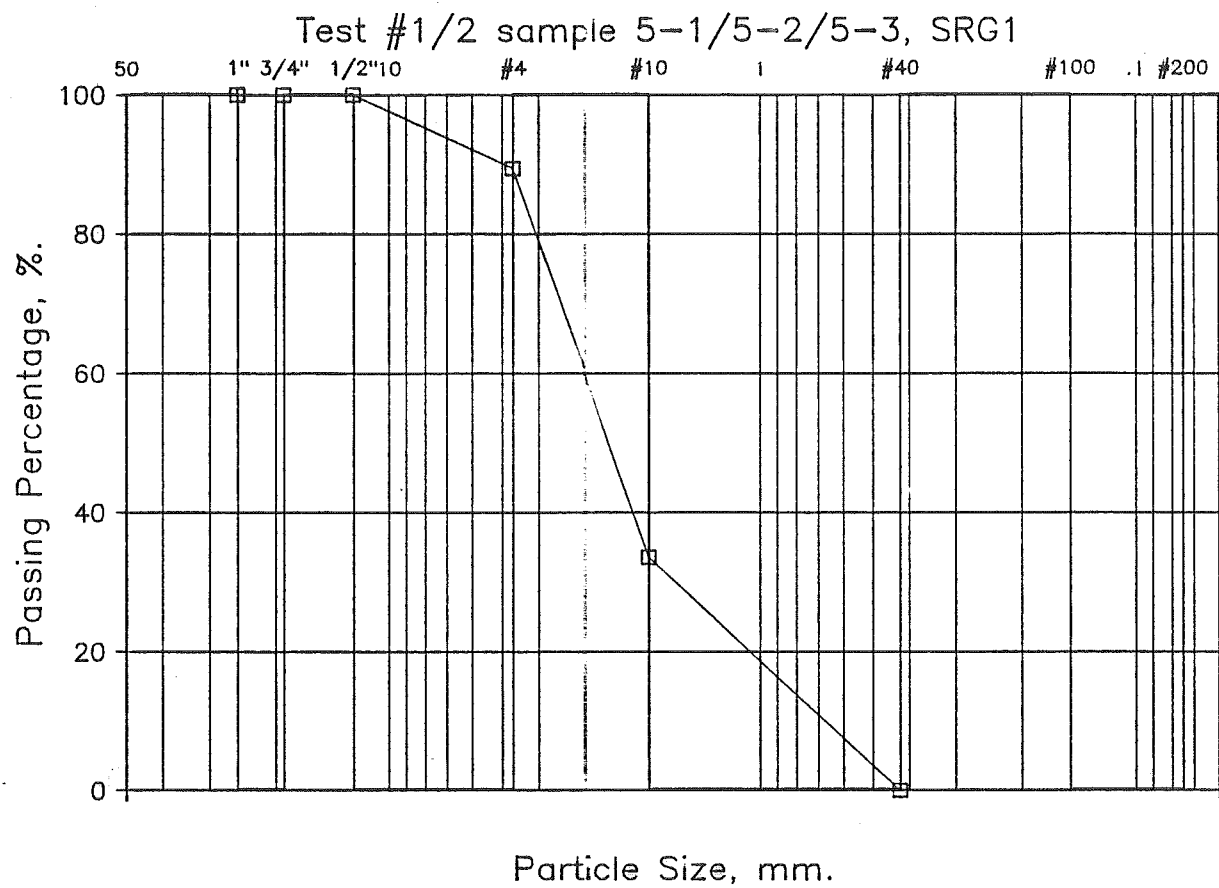
Figure 19. SRG1 Grain Size Analysis after 50 Minutes of Precipitation and 10 Minutes of Overland Flow

The cumulated samples of the panels after 10 minutes of the combined flows still had 88 percent of the plus number 40 material finer than the number 4 sieve size (Figure 19). It is apparent that under the added stress of the 1.2 gpm flow the plus number 4 particles are relatively stable. These coarse particles are able to develop new armor at the slope surface.

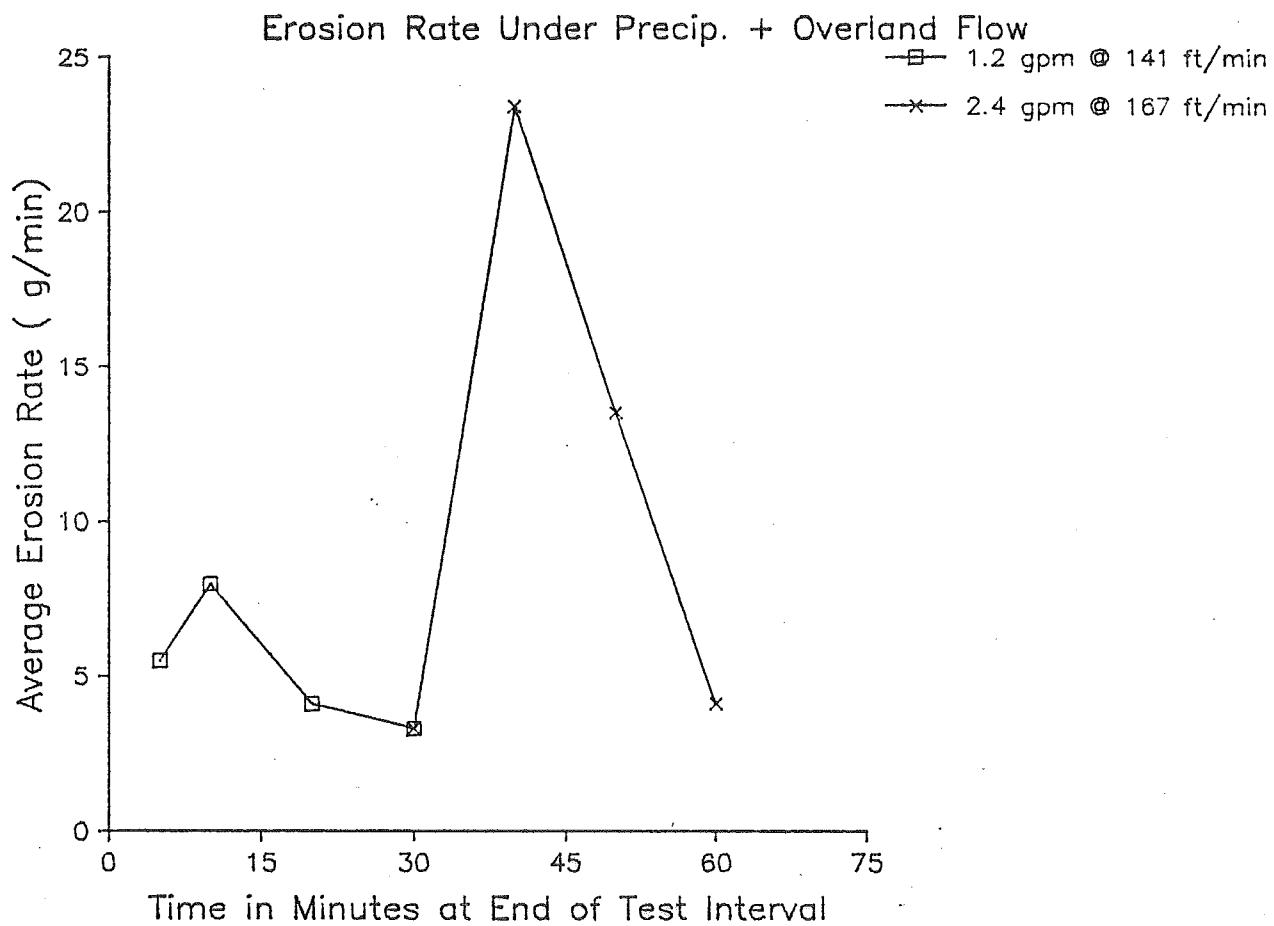
Figure 20. SRG1 Erosion Vs. Time for 2:1 slope
and $Q = 1.2$ & 2.4 gpm (4.5 & 9.1 L/min)

At the completion of the initial 10 minutes of flow with both precipitation and overland flow applied, the combined flow testing was continued for SRG1. The flow volume of 1.2 gpm was continued but the overland flow velocity was increased to 141 ft/min (43.0 m/min). The rate of erosion versus time for this additional testing is provided on Figure 20.

When Figures 20 and 15 are compared it is apparent that when testing started with the same flow but at a higher velocity, the erosion rate increased. However, the armoring associated with the overland flow of 1.2 gpm and 78 ft/min was considerable. The rate of erosion of approximately 47 g/min associated with the first overland flow after 10 minutes is approximately 5 times greater than the rate of erosion for the second interval, with a velocity of 141 ft/min, after the same time

The reason for the increase in the rate of erosion shown on Figure 20 between 5 and 10 minutes is believed to again be the initial relocation of some coarse particles. When the velocity of flow increased by over 80 percent, some particles were unable to resist the new flow environment without an adjustment in position. The combined samples of the plus number 40 material eroded after 10 minutes at the higher velocity flow were 95 percent finer than the number 4 sieve size. (Figure 21). Not only does the slope continue to armor, as demonstrated by the reduction in the rate of erosion, but primarily the transport of particles smaller than the number 4 sieve size continues.

As flow at the velocity of 141 ft/min continued the rate of erosion continued to decrease for the following two 10 minute test intervals, (Figure 20). The rate of erosion decreases from 8.0 to 3.3 g/min over the 10 minute to 30 minute test periods.

After 30 minutes of testing at the 1.2 gpm and 141 ft/min flow rates was completed the flow was increased. The volume was increased to 2.4 gpm and the flow velocity increased to 167 ft/min (50.9 m/min). The rate of erosion for the next 10 minute test interval increased to 23.4 g/min, (Figure 20). At this more severe erosion condition the percentage of plus number 4 size particles that were eroded increased to 27 percent of the collected combined sample (Figure 22).

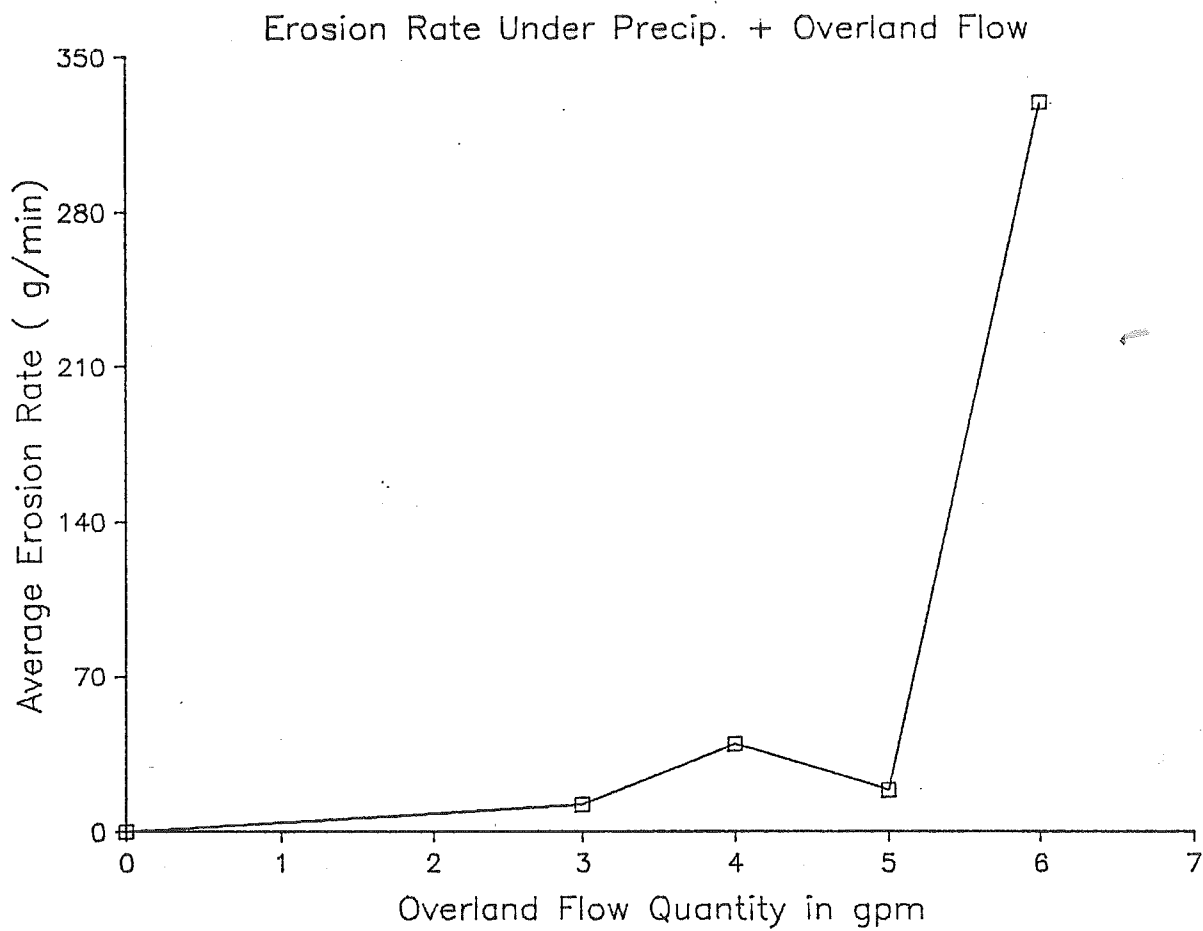
Figure 26. SRG1 Erosion Vs. Overland Flow Quantity,
2:1 Slope With a Flow Velocity of +170 ft/min (+51.8 m/min)

Panel 3 of SRG1 was selected for additional testing above the 2.4 gpm overland flow rate. The flow rate with precipitation was increased to 6.0 gpm. The rate of erosion increased 10 fold as the flow rate increased from 5.0 to 6.0 gpm (Figure 26).

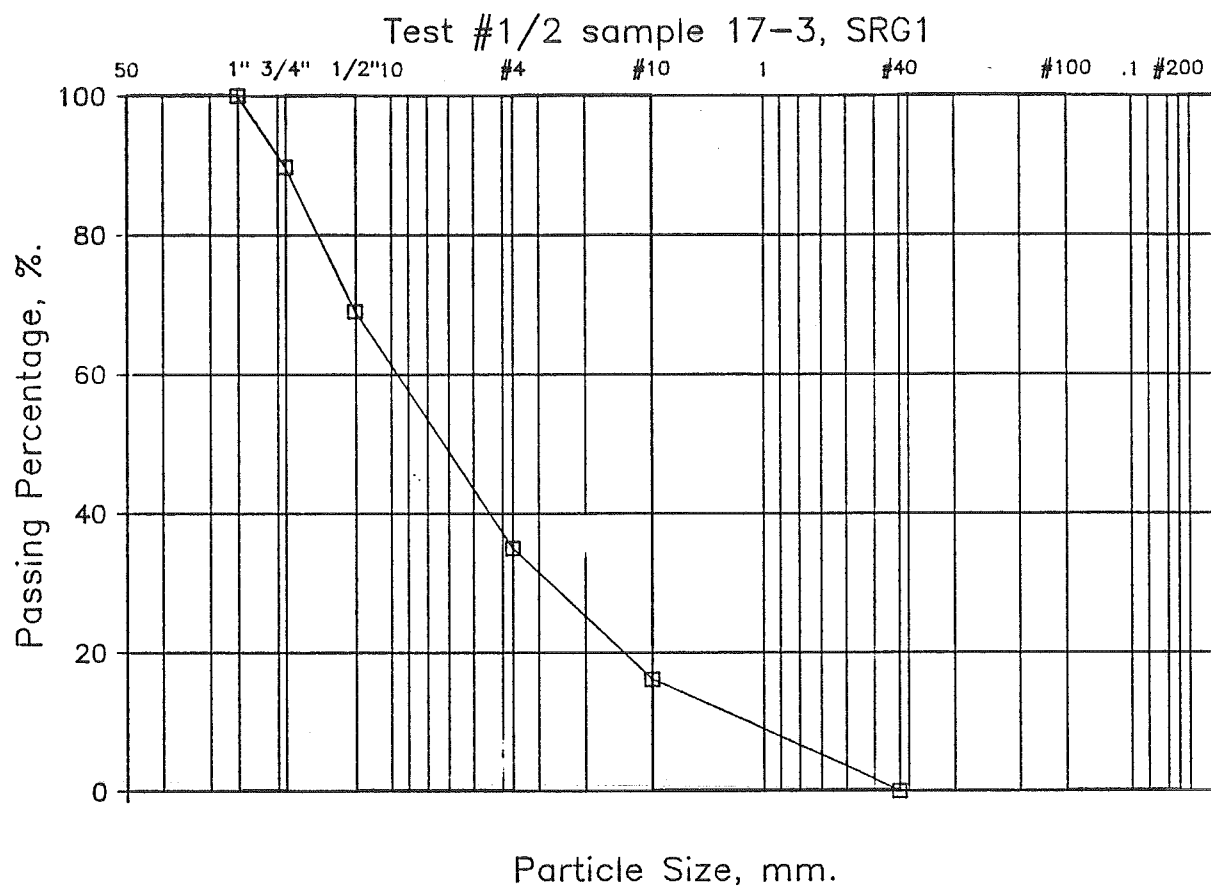
Figure 27. SRG1 Grain Size Analysis, Panel 1, 10 Minutes
of Combined Flow at 6.0 gpm (22.7 L/min)

The removal of the armoring that had been formed during the prior testing began when the flow reached 6.0 gpm. As can be seen on Figure 27, the surface protection was being destroyed. Slope surface particles as large as 0.75 inches were being transported. In fact a straight channel had been cut in the SRG1, though the channel had not cut through to the Mirafi 6000 material.

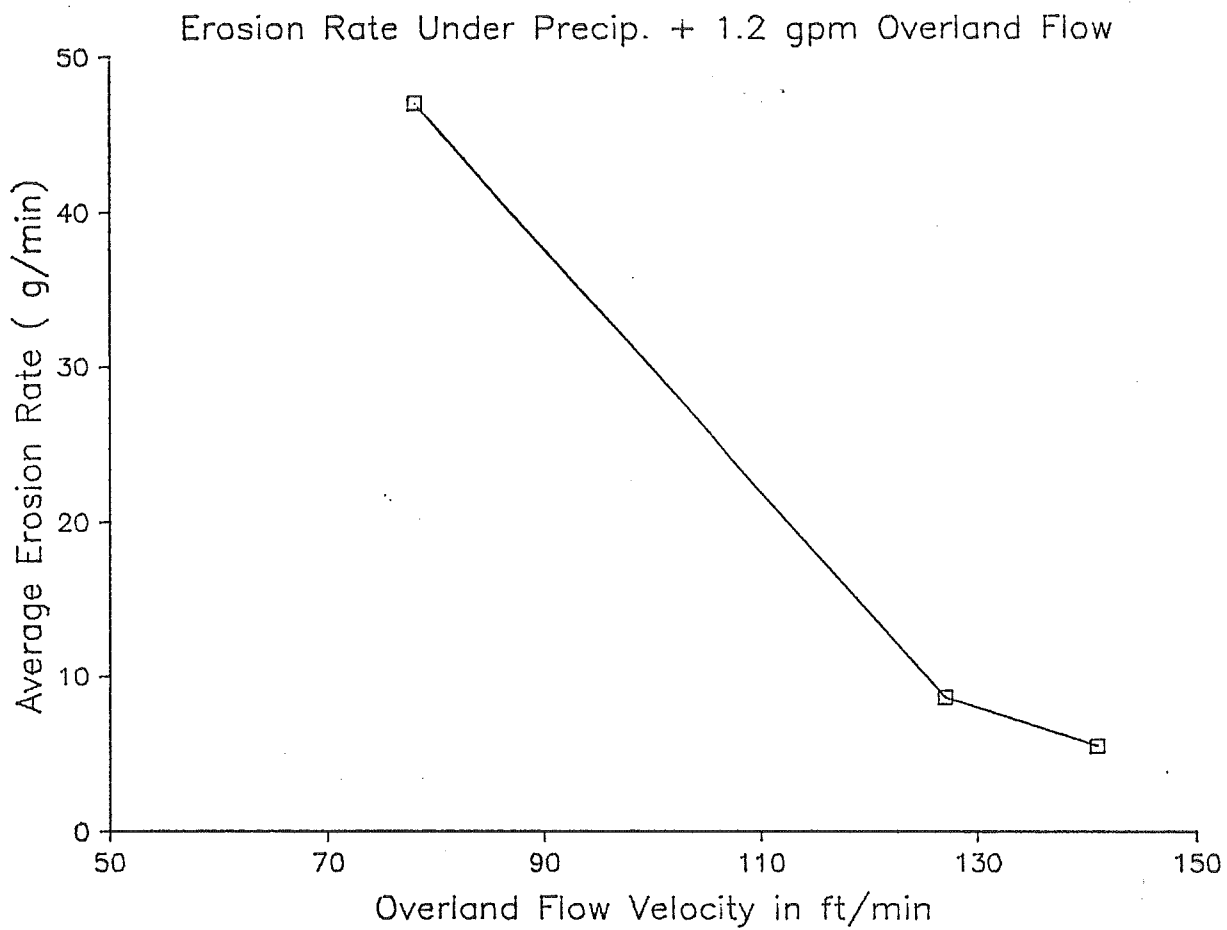
Figure 28. SRG1 Erosion Rate Vs. Overland Flow Velocity, 2:1 Slope and 1.2 gpm (4.5 L/min)

To depict the relationship between erosion rate and overland flow velocity when a 2:1 slope of SRG1 material is stressed by precipitation and overland flow, Figure 28 was prepared. When the flow rate is 1.2 gpm and the velocity is less than 141 ft/min the slope of SRG1 material will armor itself. As can be seen in Figure 28, the erodibility of the SRG1 material was not increasing even when the erosion stress was increasing due to the development of a resistive surface.

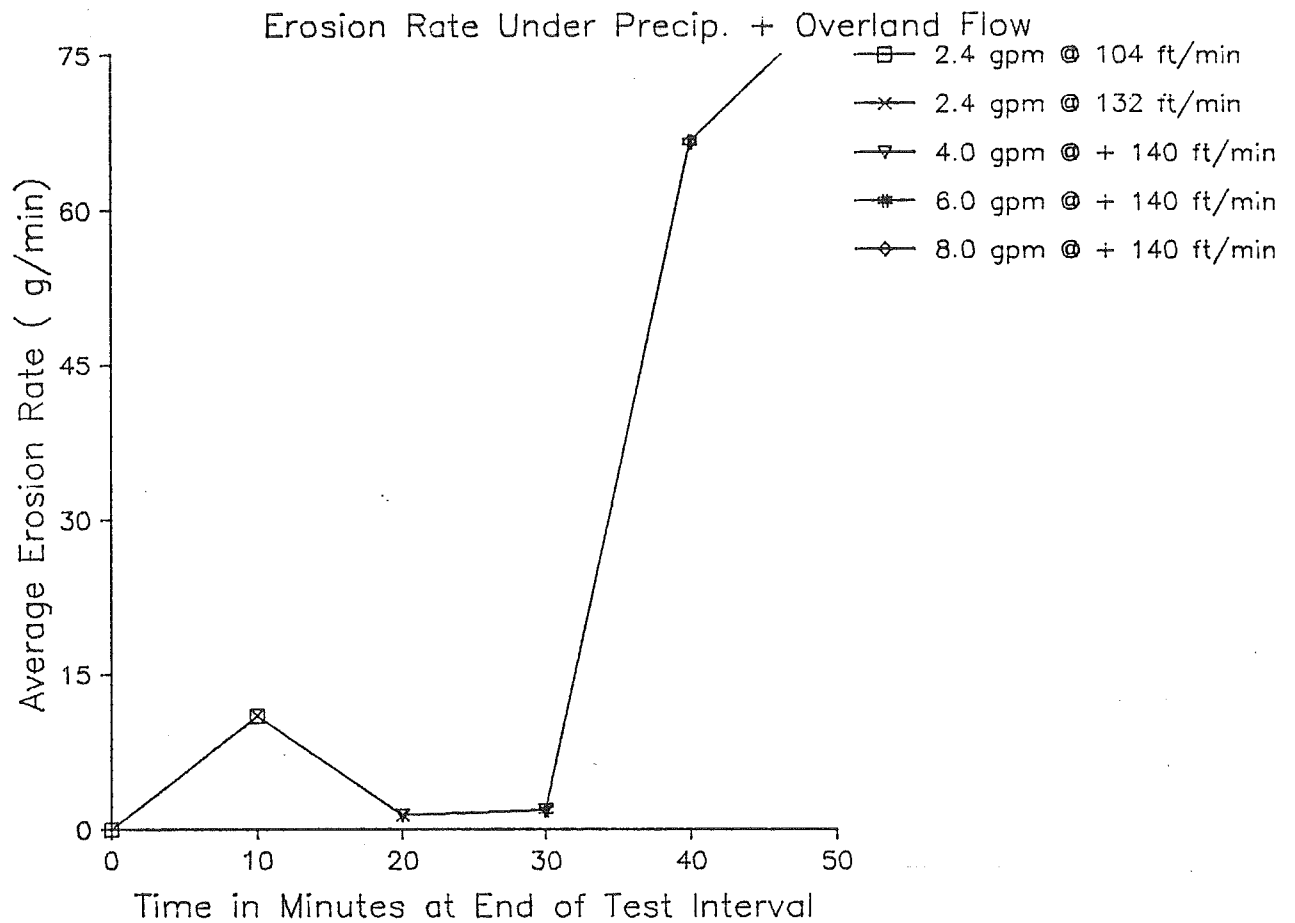
Figure 29. SRG1 Test 2, Erosion Rate Vs. Time, 2:1 Slope and Varying Overland Flow Conditions

Another test was performed using the SRG1 material. This test examined the resistance to erosion at high overland flow rates while the slope was kept at 2:1. The overland flow was increased to 8.0 gpm (30.3 L/min) which resulted in panel failure for two of the panels, (Figure 29). This data and the data from the first series of SRG1 tests show similar behavior. The precise flow at which the slope fails appears to lie between 6.0 and 8.0 gpm flow rates. The differences between panels is sufficient to produce this range in maximum erosion stress resistance. It is adequate to know the conditions at which stress will have a high probability of producing an erosion channel when SRG1 material is placed on a 2:1 slope. These conditions are met when the precipitation and overland flows are combined and the overland flow component is greater than 4.0 gpm.

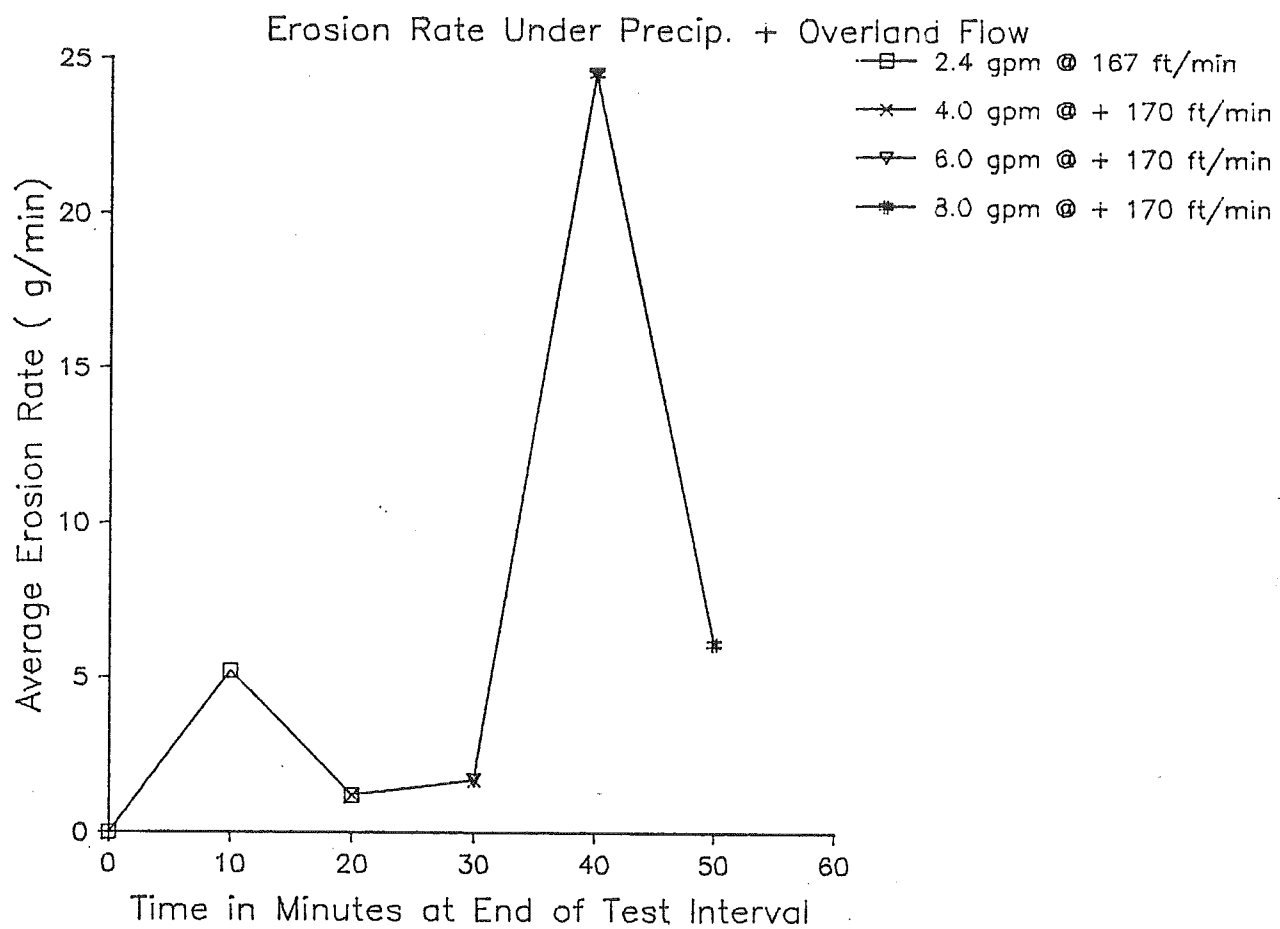
Figure 30. SRG1 Test 2, Panel 3, Erosion Rate Vs. Time, 2:1 Slope

An example of the variability to be found on "identical" panel surfaces is depicted on Figure 30. The results of panel 3 present proof that for an advantageous arrangement of surface particles even SRG1 material is resistant to combined flows with an overland component of 8.0 gpm. It should be noted that considerable movement and surface erosion occurred prior to the development of this rather stable surface. The sample at the end of the 8.0 gpm 10 minute event contained no particles larger than the number 4 size. This indicates that the preceding flow events were responsible for the slope resistance (Figure 31).
